#4. Bergstrom #1 & #2

**Watershed Protection
Development Review**

3.4 #4, BERGSTROM AIR FORCE BASE

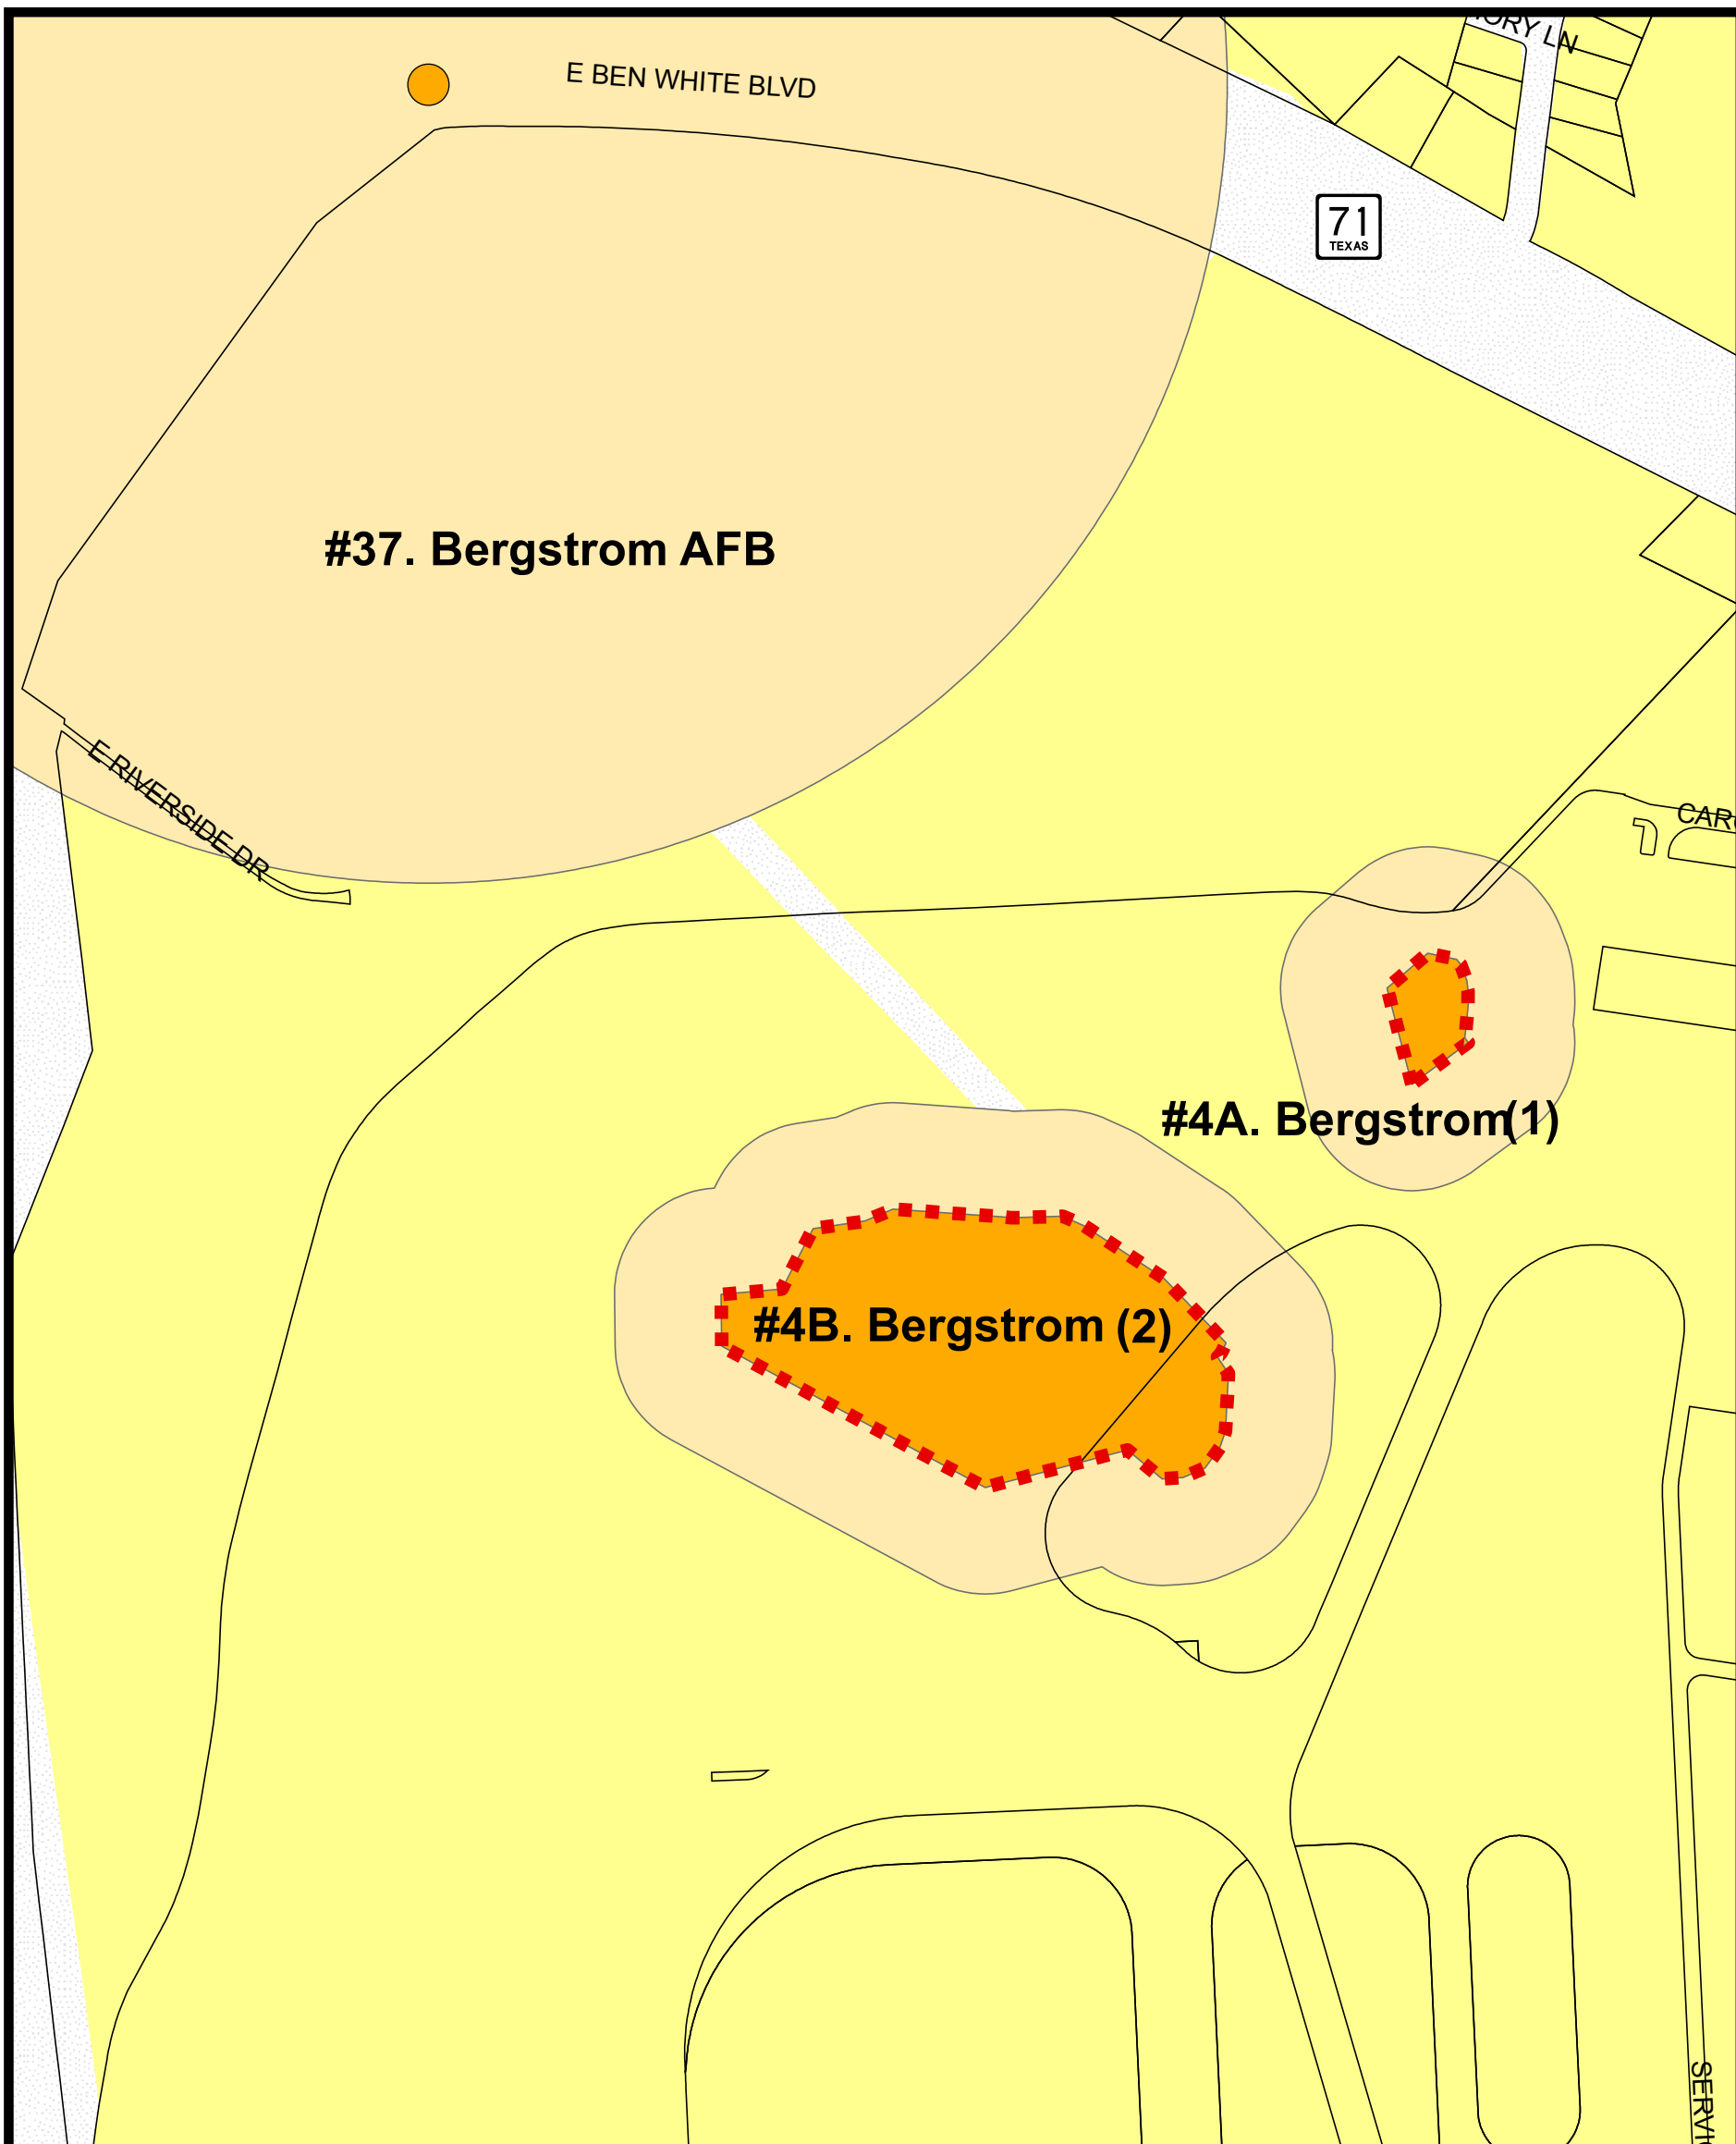
Extent: Landfill # 4 includes two landfilling areas identified as Landfills 01 (2 acres) and 02 (16 acres) by the Air Force. Both of these landfills were investigated in 1994 as part of the Base closure, and were closed under the Installation Restoration Program. The landfills are located within Airport property, and therefore are not accessible by the general public.

Current Conditions: Landfill 01 is located on the western end of the cargo hangers, and is adjacent to parking areas and a taxiway. The landfill has been graded smooth, and has been capped with asphalt. There are no structures on this landfill.

Landfill 02 has been graded smooth, and the portions not covered by the concrete taxi-way have been capped with asphalt. With the exception of the runway portions, there are no structures on or near this landfill. Current conditions associated with this site do not appear to pose a material concern to human health or the environment, or represent a regulatory violation.
